AVIATION OCCURRENCE REPORT

ARROW AIR INC.
DOUGLAS DC-8-63 N950JW
GANDER INTERNATIONAL AIRPORT,
NEWFOUNDLAND
12 DECEMBER 1985
REPORT NUMBER 85-H50902

28 October 1988

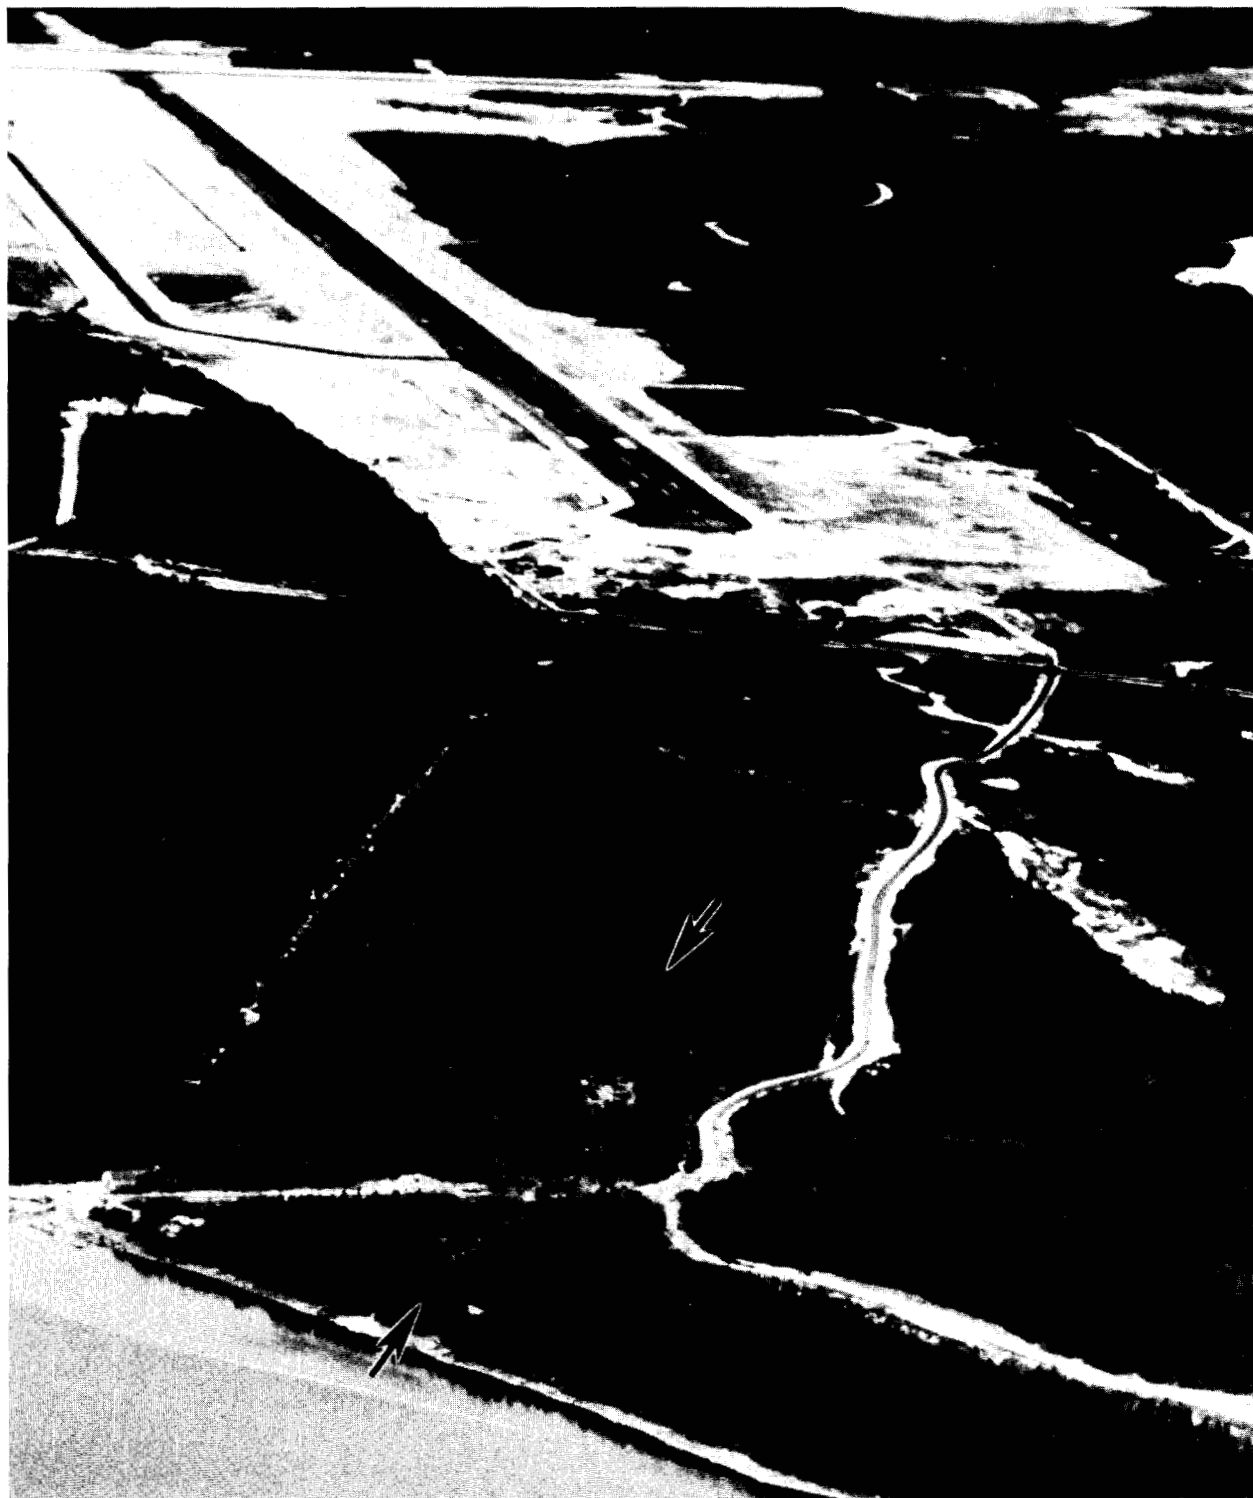
Figure 1.1. Oblique Air Photo of Accident Site

The accident occurred at 1016 during the hours of darkness at lat 48°54'40"N, long 54°34'35"W* at an elevation of 279 feet above sea level (asl).

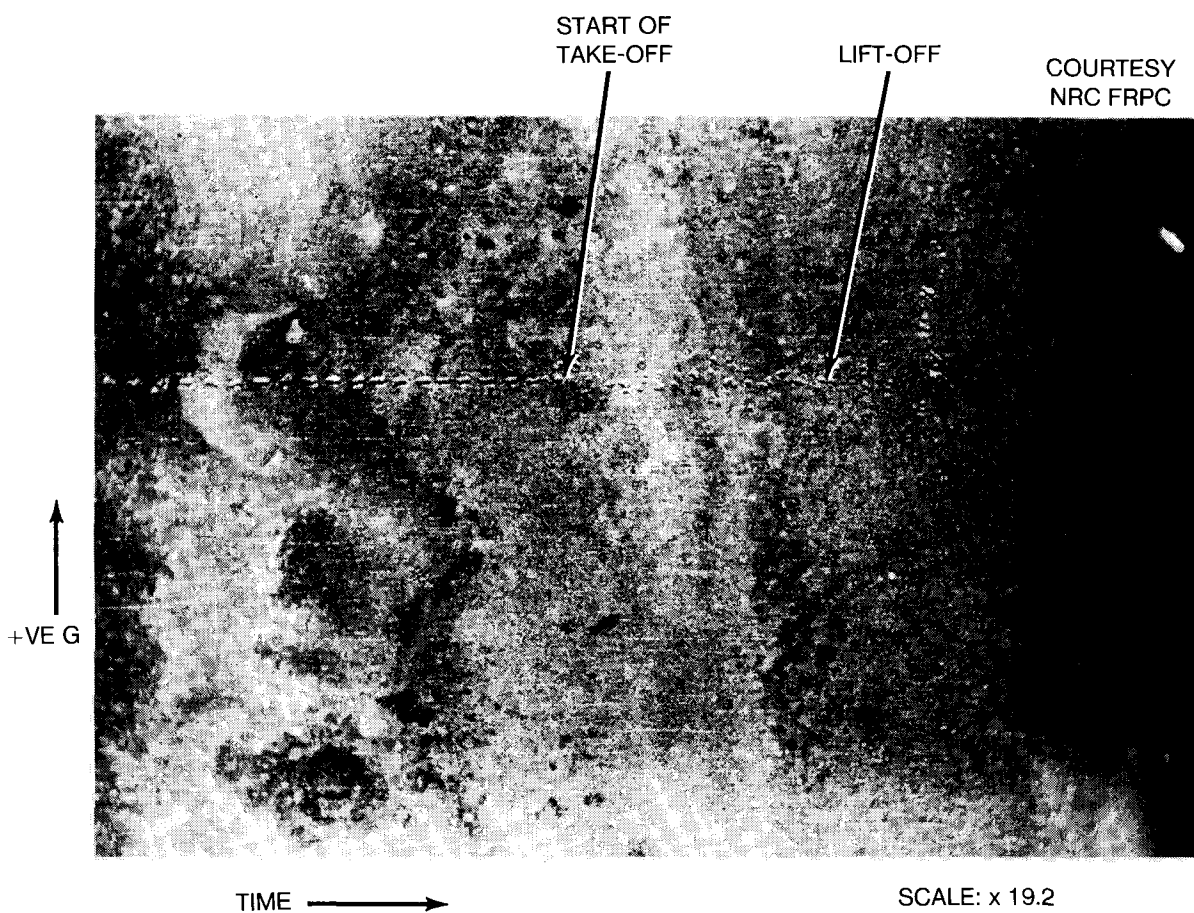
Figure 1.5. Photo of FDR Vertical Acceleration Trace

No reliable time sequence of vertical acceleration values suitable for estimating flight path was derived. In addition, actual vertical acceleration could not be calculated because pitch and roll information was not available. It was determined that, within a few seconds of lift-off, the recorded vertical acceleration value reached a peak value of 1.26G (where 1.0G corresponds to level flight condition), decreased to about 0.88G, and subsequently oscillated between values as high as 1.30G and as low as 0.77G. During the last few seconds before impact, the values were almost entirely below the 1.0G level, reaching a minimum value as low as 0.72G.

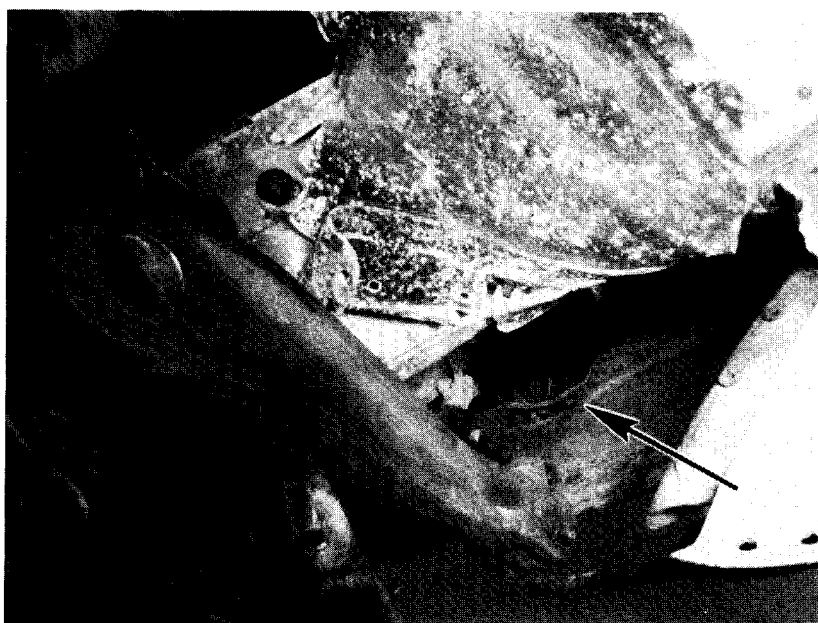
Figure 1.8. Number Four Thrust Reverser Outboard Deflector Door Upper Actuating Arm Area

OUTBOARD DEFLECTOR
DOOR UPPER ACTUATING
ARM AREA OF NO. 4
REVERSER. ARM HAS BEEN
PULLED OUT OF SLOT BY
CRASH DAMAGE. NOTE
DAMAGE IN AFT END OF
SLOT AT ARROW.

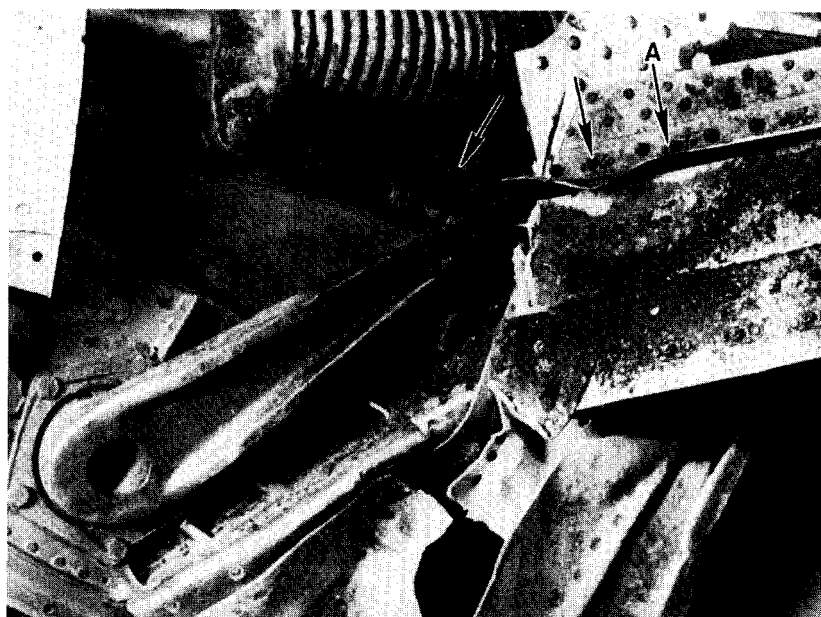
Figure 1.9. Number Four Thrust Reverser Inboard Deflector Door Lower Actuating Arm Area

THRUST REVERSER NO. 4
INBOARD DOOR LOWER
ACTUATING ARM. SKIN HAS
BEEN CUT AND FOLDED
BACK TO SHOW
DEFORMATION IN EDGES OF
SLOT (ARROWS). NOTE THAT
ARM IS IN THE DOOR
DEPLOYED POSITION.

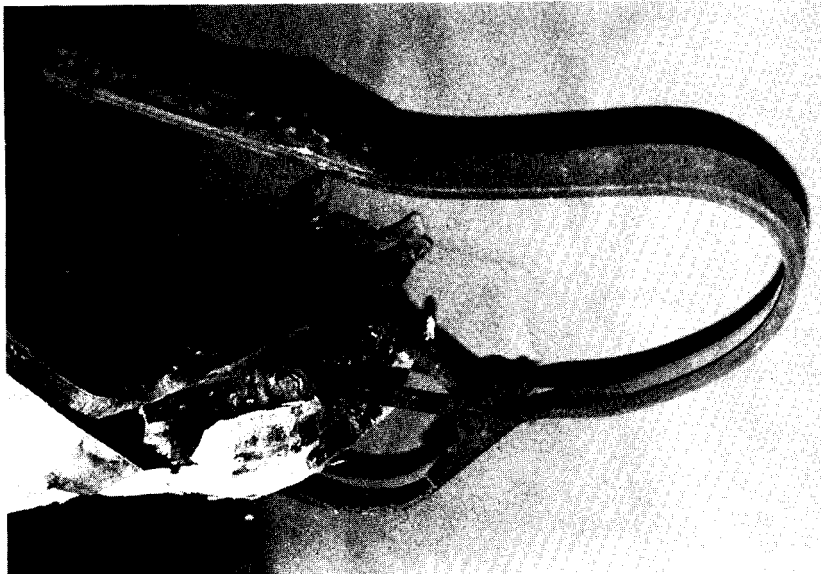
Figure 1.11. Number Four Thrust Reverser Lower Track

THRUST REVERSER NO. 4 LOWER TRACK. AFT END OF TRACK IS AT TOP IN PHOTOGRAPH.

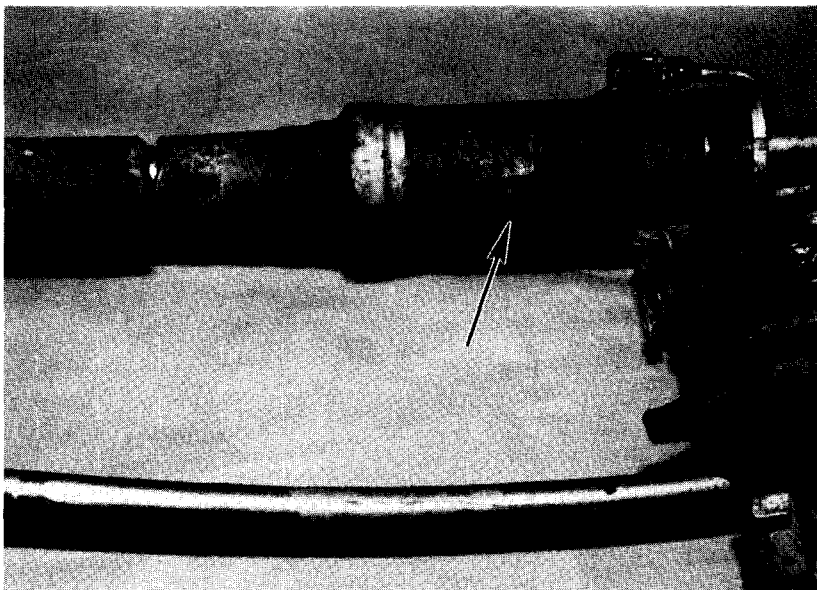
Figure 1.12. Number Four Thrust Reverser Hydraulic Actuator

THRUST REVERSER NO. 4
HYDRAULIC ACTUATOR.
NOTE SPLIT IN OUTER
CYLINDER.

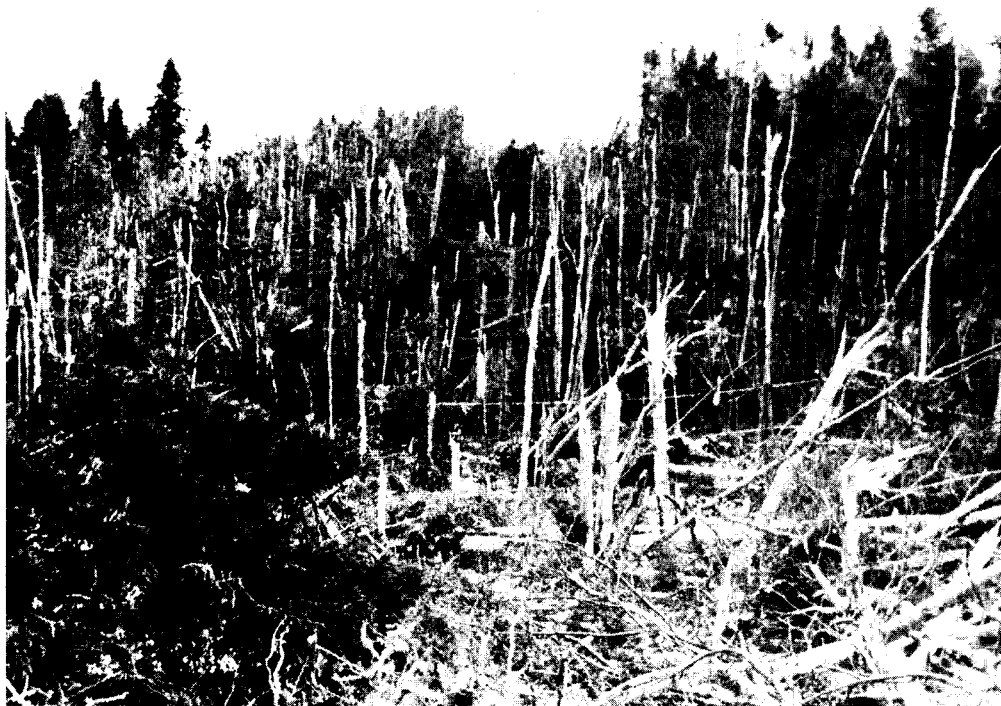
Figure 1.13. Photo of Tree Swath Cut by Aircraft

Using analytical plotters, three dimensional measurements were made of 378 trees which had been cut by the aircraft prior to ground impact (See Figure 1.13.). A 1/100 scale model of the tree-cut zone was then constructed, and a detailed 1/100 scale die cast model of a Douglas DC-8-63 aircraft was mated to the tree pattern (See Figure 1.14.). Flaps were placed on the model at an 18-degree configuration to match post-crash investigation findings. By accurately measuring the orientation of the aircraft model in the tree pattern at increments along its flight path, the attitude of the aircraft and the flight path angle were determined. Measurements indicated that the aircraft first contacted the tree canopy in a seven-degree right bank, nine-degree pitch (the angle between the longitudinal axis of the fuselage and the horizontal), and a 10-degree yaw right attitude, on a descending, 12-degree flight path angle (the angle between the flight path and the horizontal).
